# Evaluation of Stream Bank Erosion along the Middle and East Branch Chillisquaque Creek.

## Summary of summer 2005 internship.

Prepared by Christy Bowersox of Lycoming College Clean Water Institute (CWI) intern under supervision of Dr. Mel Zimmerman, Department of Biology, Lycoming College. Other student interns participating on project include: Amanda Forsburg and Alex Mass from Bucknell University, Laura Wirpsza from Susquehanna University, and Stephanie Benfer from Bloomsburg University. This project was funded by a USFW grant to SEDA-COG and a grant from the Degenstein Foundation.

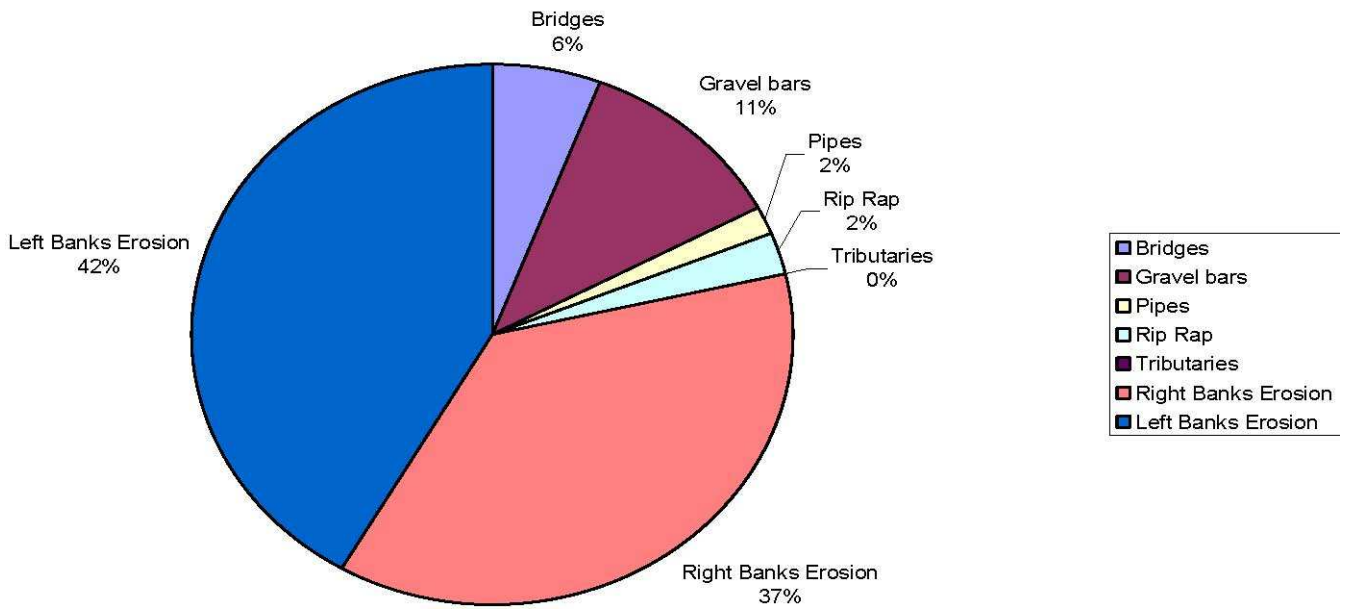
**Figure 2. Middle Branch Chillisquaque Creek Disturbances**

A total of 283 observations were noted along Chillisquaque Creek. Of these, 122 were located on the Middle branch and 161 on the East branch. These observations are summarized in Table 1. Figure 2 illustrates the make-up of the various disturbances in the Middle branch of Chillisquaque Creek. Of the observations in the Middle branch 7 were bridges, making up 5.7% of the total observations. There were 14 gravel bars or 11.5% of the total observations. Two pipes (1.6%) and three areas of rip rap (2.5%) were found. No tributaries were found on the surveyed portion of the Middle branch. However, 96 (78.7%) erosion sites were documented. Forty-five (36.9%) of the erosion sites were located on the right bank and the remaining 51 (41.8%) sites were located on the left bank. Figure 3 illustrates the make-up of the various disturbances in the East branch of Chillisquaque Creek. Of the observations in the East branch 7 were bridges, making up 4.3% of the total observations. There were 23 gravel bars or 14.3% of the total observations. Three pipes (1.9%) and five areas of rip rap (3.1%) were found. One (0.6%) tributary was found on the

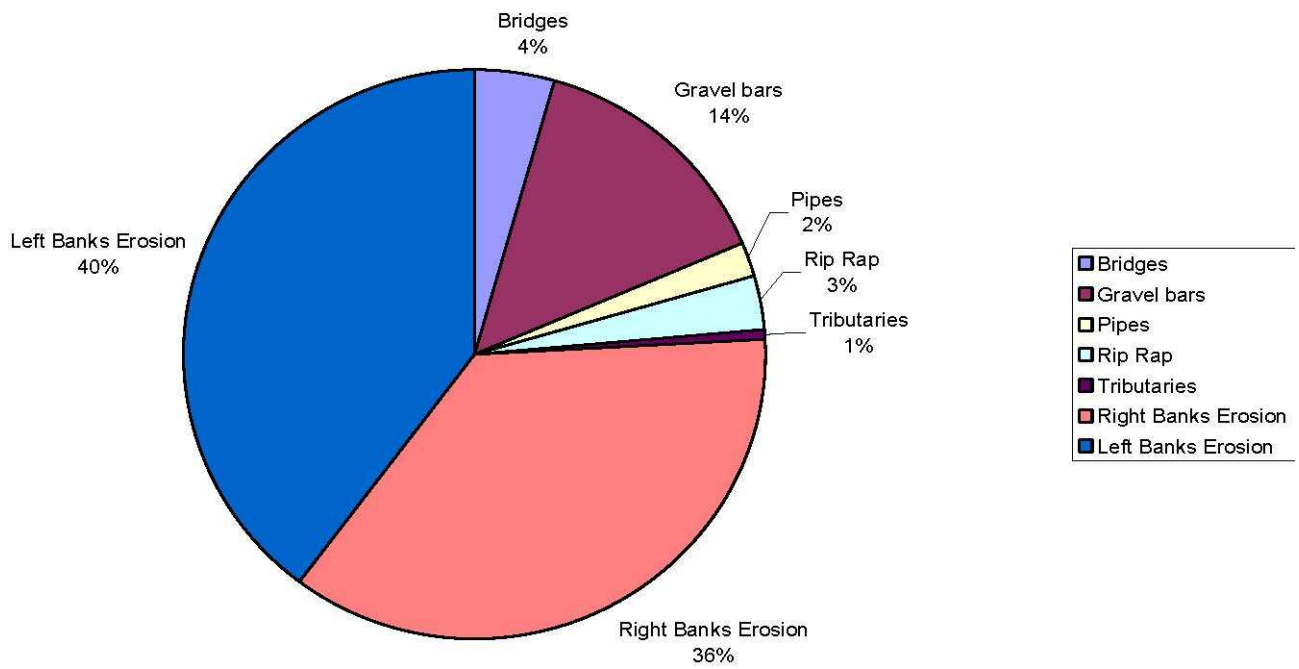
**Figure 3. East Branch Chillisquaque Creek Disturbances**

surveyed portion of the East branch. However, 122 (75.8%) erosion sites were documented. Fifty-eight (36.0%) of the erosion sites were located on the right bank and the remaining 64 (39.8%) sites were located on the left bank.
