Table 1. Summary of disturbances along Mahoning Creek.

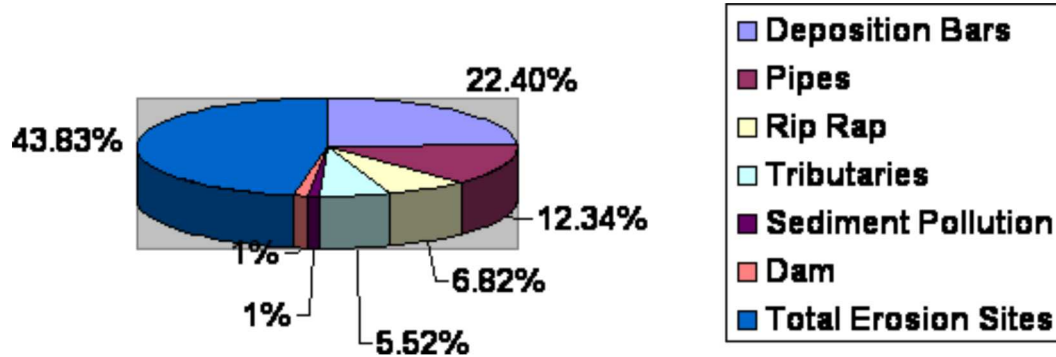
<b>Structures</b>	<b>Amount</b>	<b>Percentage out of 308 sites</b>
Bridges	26	8.44%
Depositions Bars	69	22.40%
Pipes	38	12.34%
Rip Rap	21	6.82%
Tributaries	17	5.52%
Dam	1	<1%
Sediment Pollution	1	<1%
Total Erosion sites	135	43.83%
Right Banks	68	50.37%
Left Banks	67	49.63%

**Figure 1. Summary of disturbances along Mahoning Creek.**
