Restoration of Big Bear Creek (Lycoming County, PA)

By: Dr. Mel Zimmerman

Biology Department Lycoming College

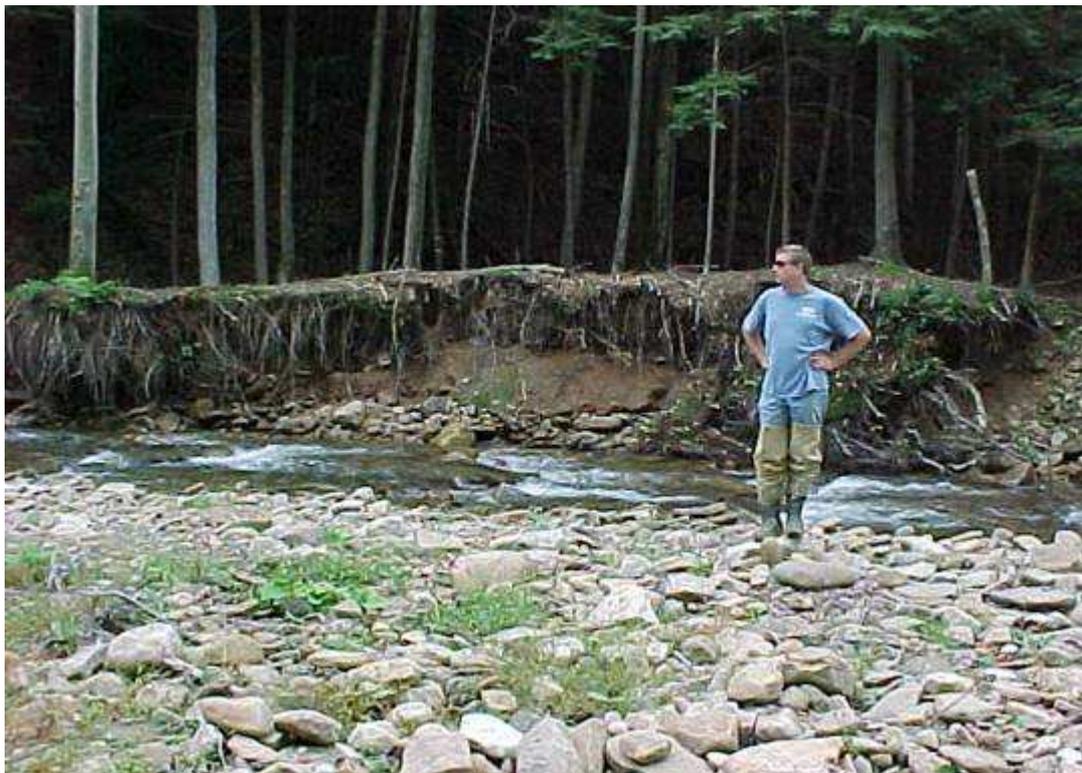
Severe Bank Erosion at Big Bear Creek prior to project

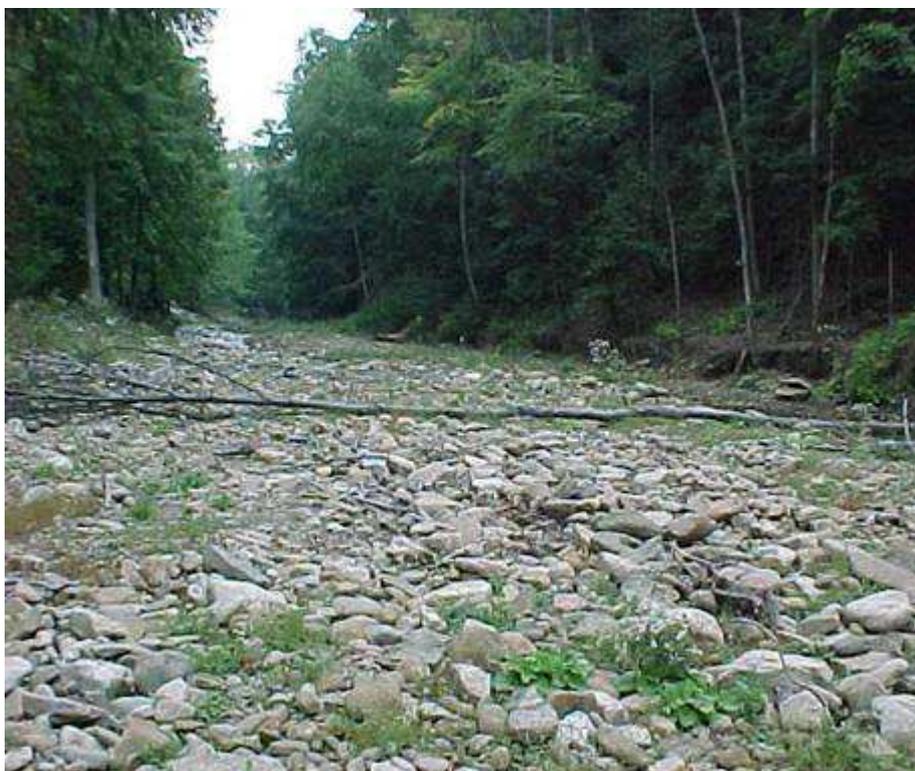
Over widened Channel with Subsurface Flow (this occurred in 6% of project area prior to restoration)

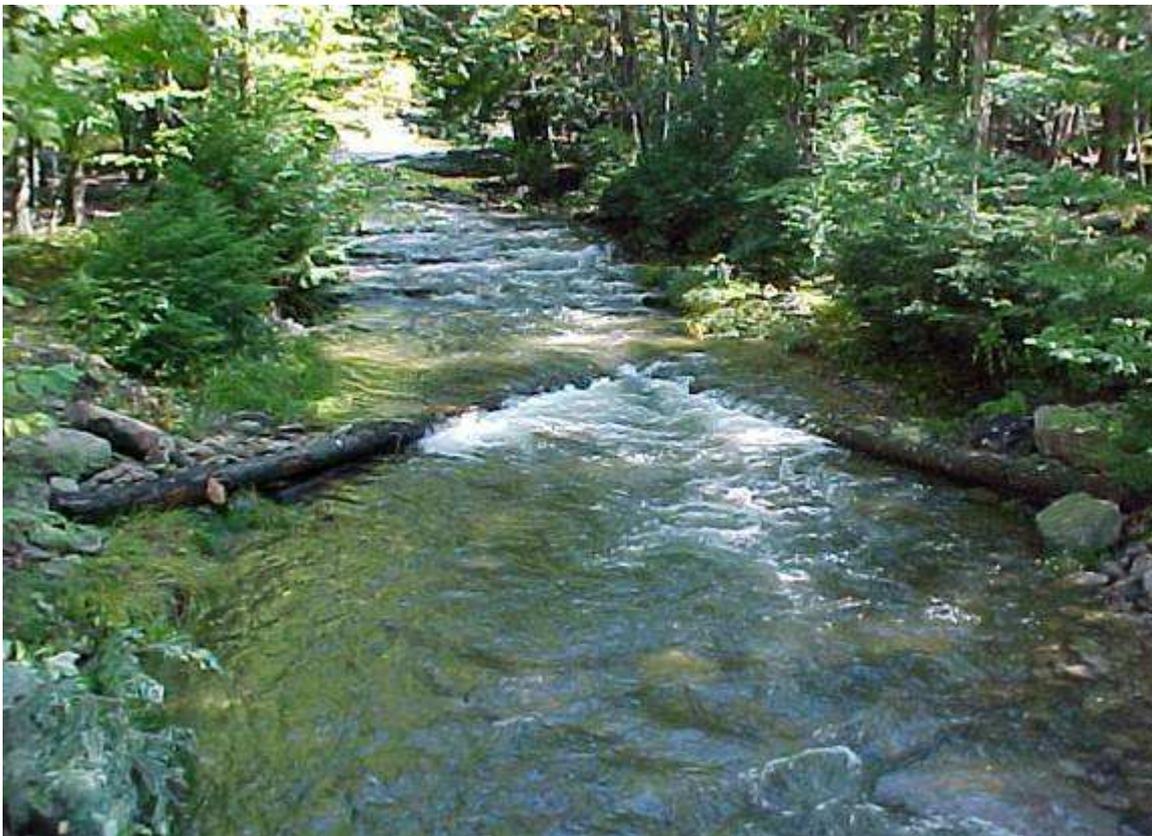
Test Run of log vein structure 1996

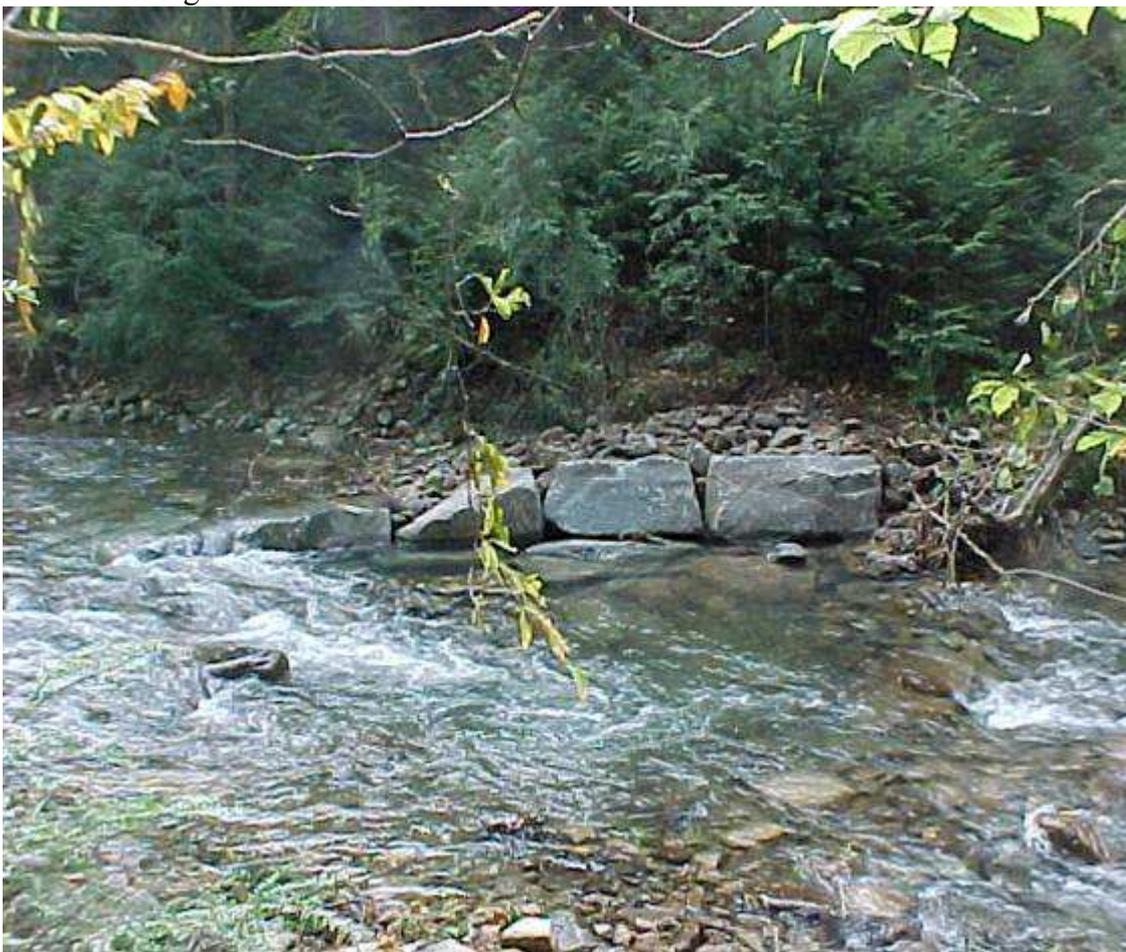
J- Hook Vein

In 1999, the Dunwoody Big Bear Hunting and Fishing Club pulled together a number of partners (including U.S. Fish and Wildlife, PA-DEP Growing Greener, and others) to restore a 3.8 mile section of Big Bear Creek (Lycoming Co., PA) using Natural Stream Channel Design, which incorporates science of fluvial geomorphology. The Big Bear Creek Watershed is 17-square miles and the project occurred in the lower 4 miles of the stream, ending at its confluence with Loyalsock Creek. Over the last half century, instability of Big Bear Creek resulted in a stream with a high width to depth ratio (W/D ratio), large areas of bank erosion (see photos), places where the stream flowed underground (6% of the stream length in 1999), and a depressed fishery dependent on stocking. The scope (plan) of the project was to stabilize the banks, restore the proper sinuosity and W/D ratio, as well as improve habitat for the fishery. Over the next three years, after the appropriate design and permitting, a total of 127 rock “cross veins” or “J hooks” were placed in the stream by contractors (see photos). The veins maintain stream velocity and increase sediment transport by concentrating flow into the center of the stream and prevent erosion by reducing pressure on the channel sides (banks).

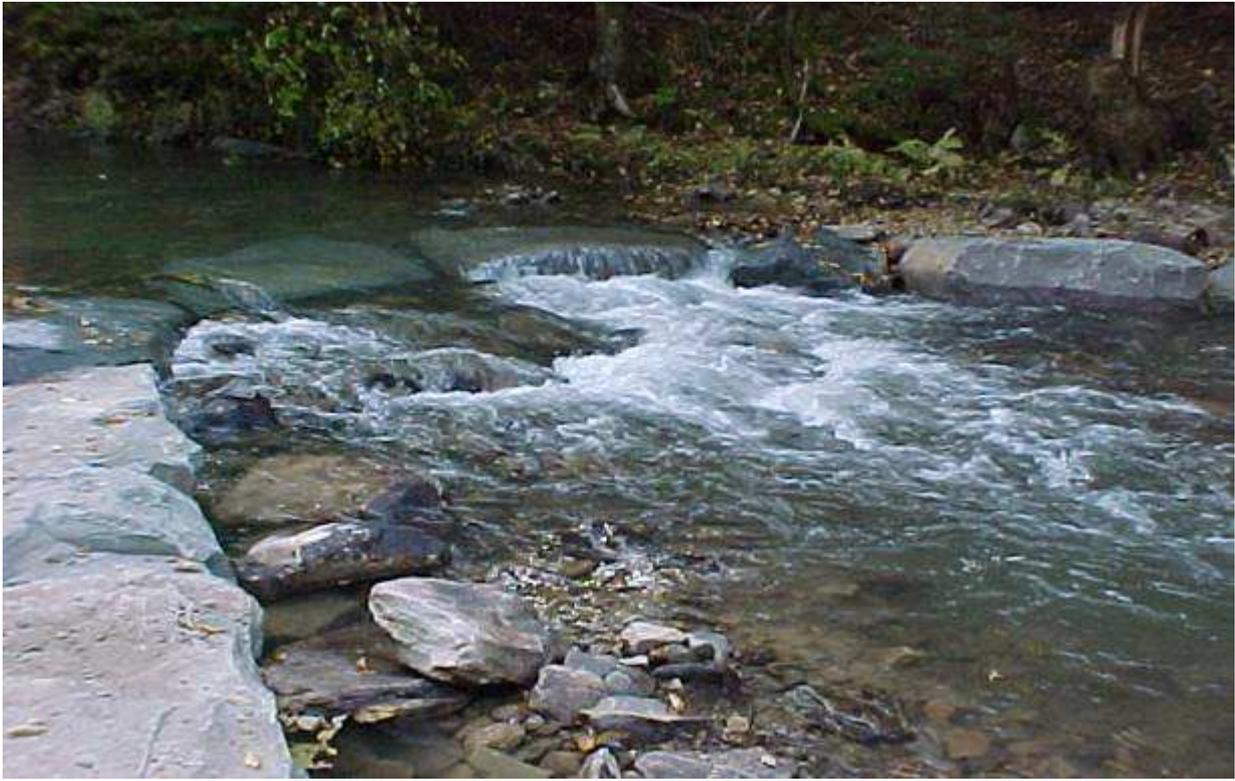
Cross Vein

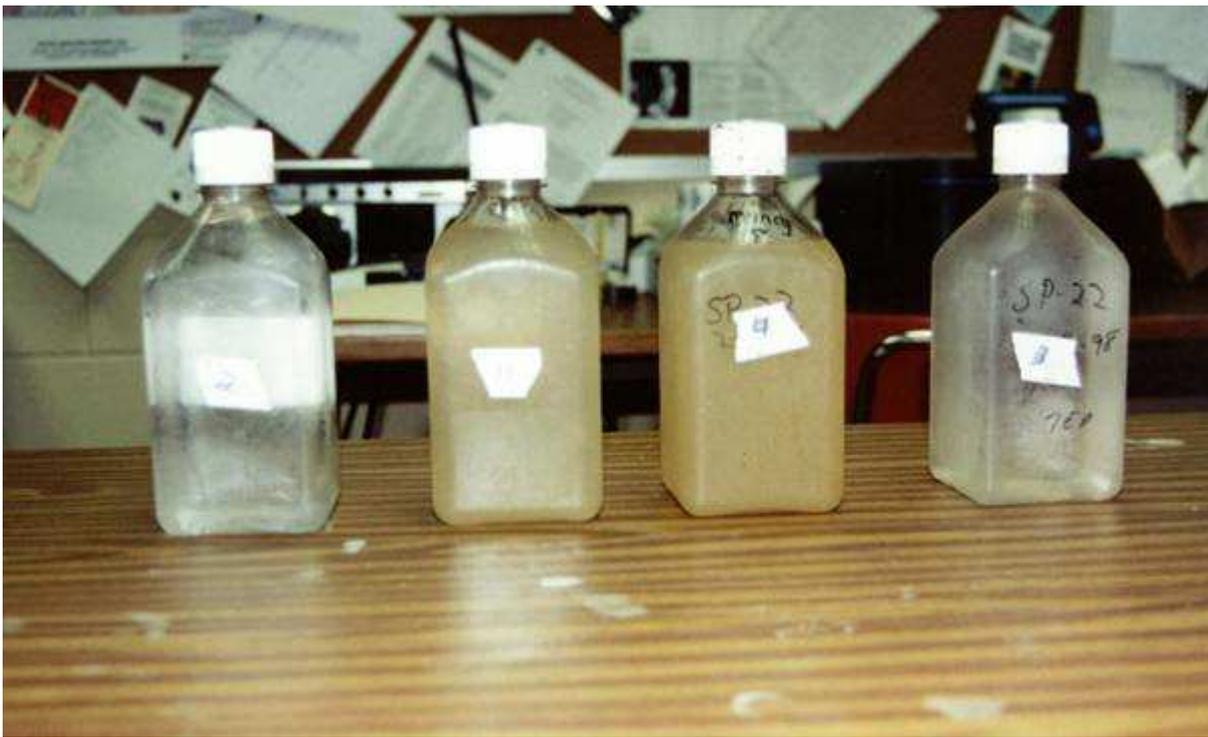
Sediment samples collected before, during, and after storm event

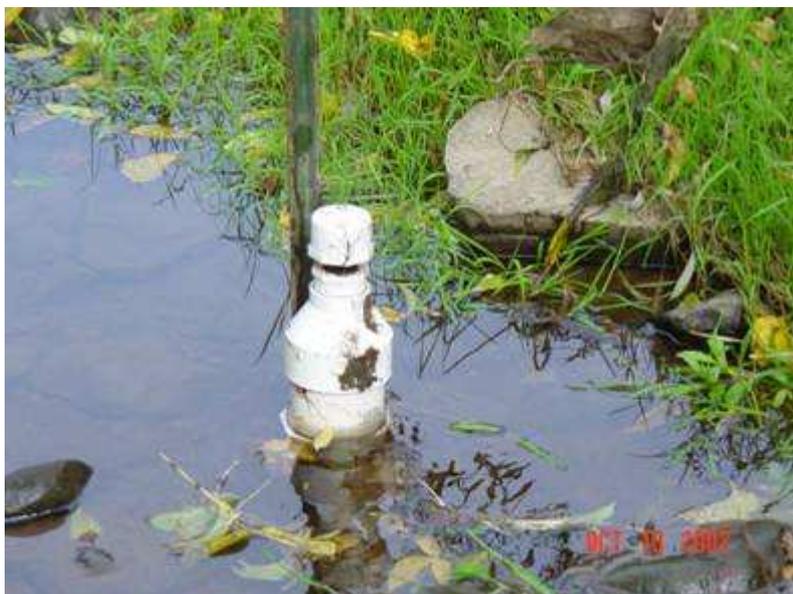
Event Sampler design (above) and in field operation (below). Collects water for sediment analysis.
