The Use of Fixed Film Media to Reduce Nutrient Levels in a Sequencing Batch Reactor

**Presented to the faculty of Lycoming College in partial fulfillment of the requirements for
Departmental Honors in Biology**

**Lycoming College Clean Water Institute in partnership with The Cromaglass®
Corporation**

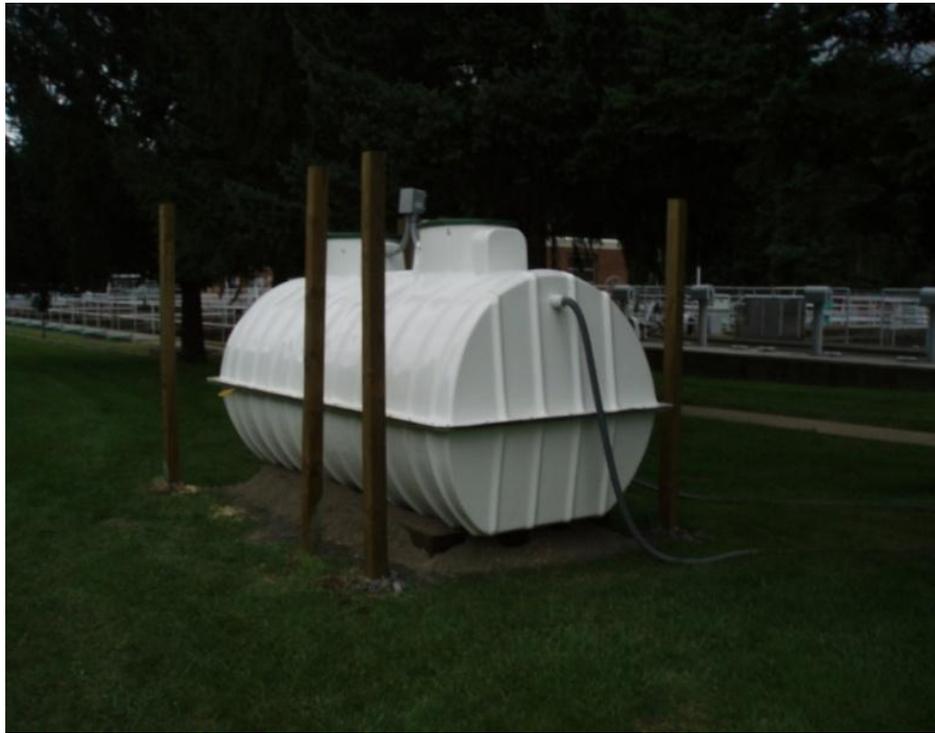
Figure 1: A CA-5 SBR unit located at the Williamsport Area Sanitary Authority

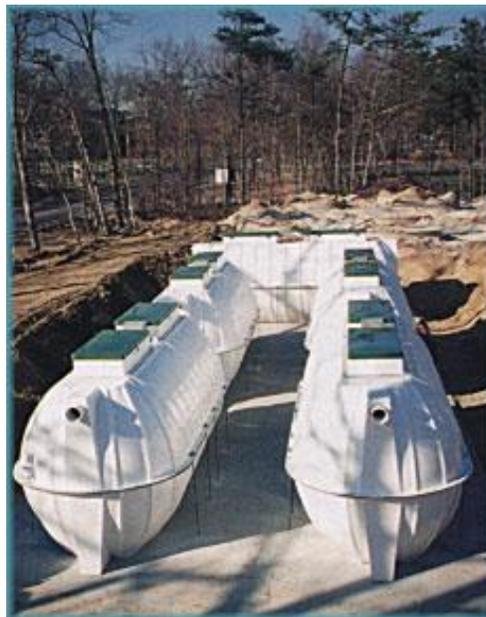
Figure 2: Five units being installed in a single site to increase the amount of wastewater that can be treated per day (Young, 2006)

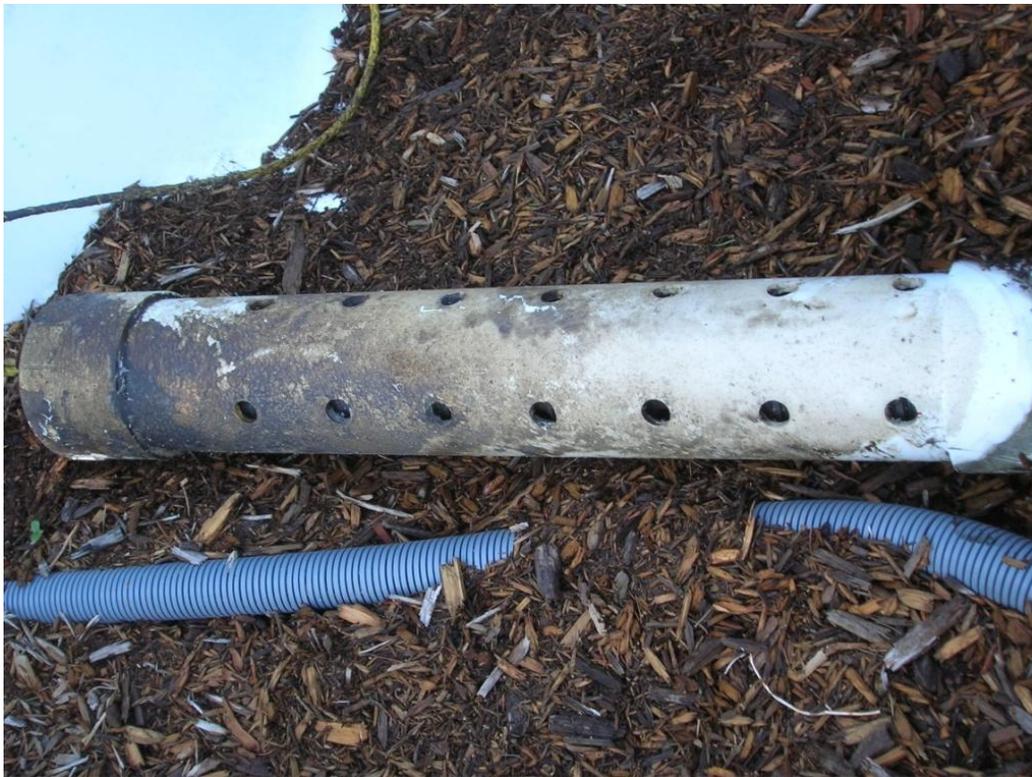
Figure 8: The fixed film media (after use in a SBR)

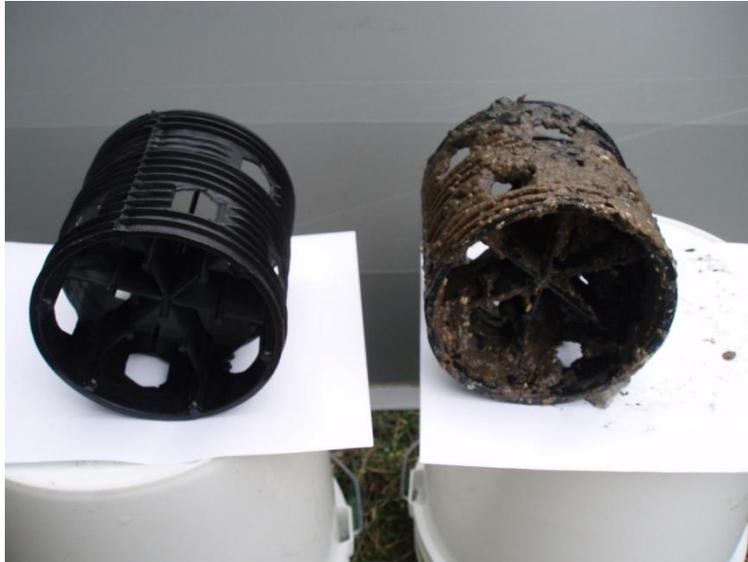
Figure 9: The coffee cans; the one on the right is brand new and clean, the one on the left has the biofilm on it

To further increase the effluent quality and decrease the nutrient levels (primarily total nitrogen because of its ability to trigger algal blooms in water systems, which may lead to eutrophication) in their systems, the Cromaglass® Corporation has developed new fixed film media technologies (Young, 2008). The fixed film media is comprised of a hollow PVC pipe (see Figure 8), capped off at both ends, filled with eight plastic matrixes called “coffee cans” (see Figure 9). The coffee cans provide extra surface area for bacterial growth; this bacterial growth is called a biofilm (see Figure 9) (Young, 2008).

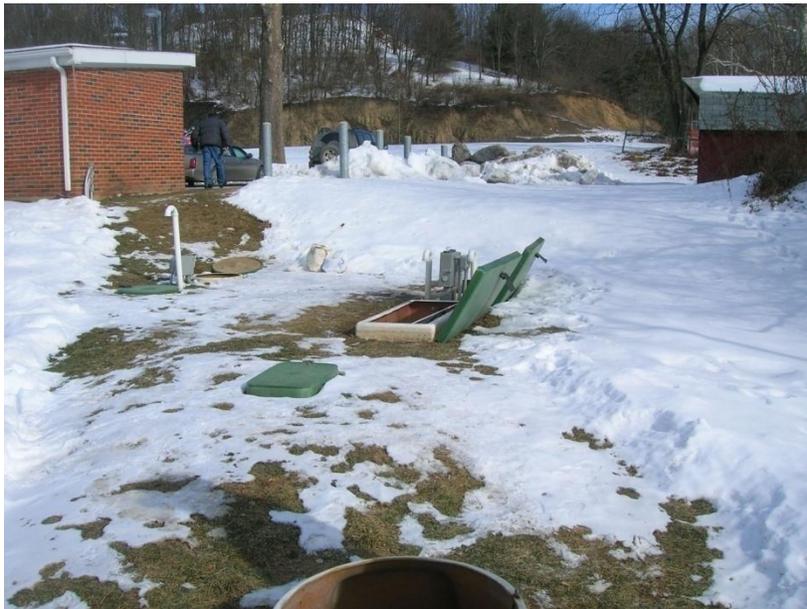
Figure 10: The Hepburn Lycoming Elementary School site, as viewed from the chlorine tank (bottom of the picture). The CA-60 SBR is in the center of the picture and the sludge wasting tank is in the left corner below the brick building

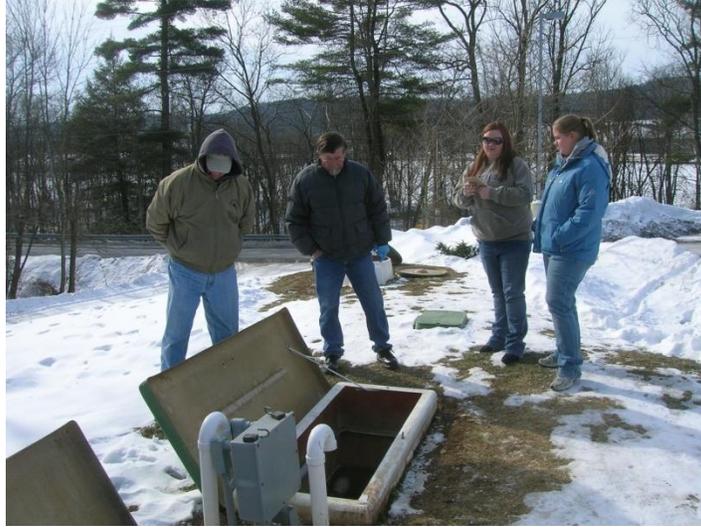
Figure 11: The maintenance hatch that covers the clarification chamber and the end portion of the aeration chamber

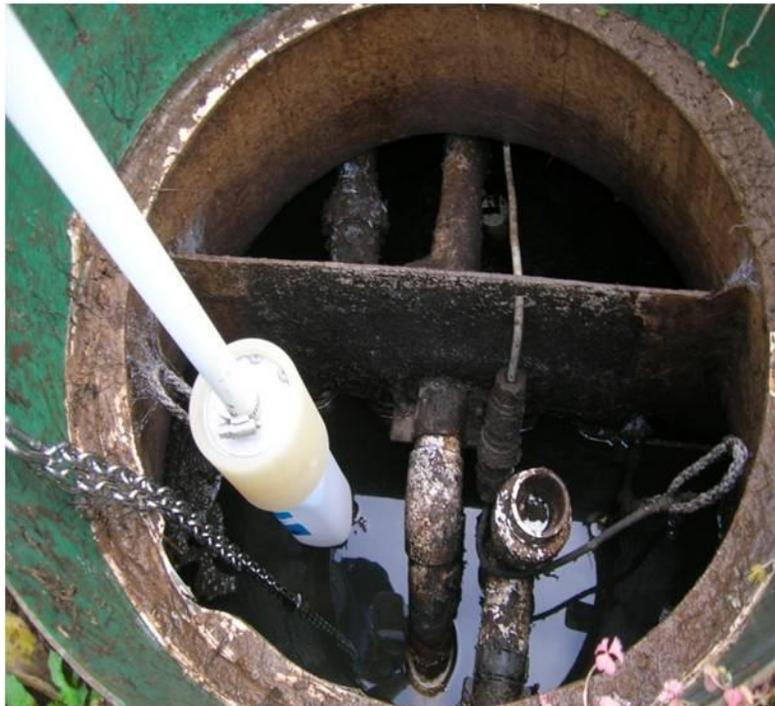
Figure 14: The 500 mL bottle attached to the grab stick

to the base of an eight foot pole. The pole had a wire that ran the internal length of the pole and attached to an apparatus inside the device that connected the bottle to the pole. This wire, when pulled, opened up holes in the attachment apparatus and allowed the sample liquid to fill the bottle (see Figure 14). The bottle was then able to be detached and used to fill up the brand new sample bottle. This had to be done twice to obtain 1000 mL of sample.
